# New York State Department of Transportation

## Yellow Flag NB22U4W001

**BIN: 1065318**

Location: Span 168, Girder G11 at Pier 167 located within scaffolding platforms installed by contractor which is located above parking lot between 38th and 39th Street.

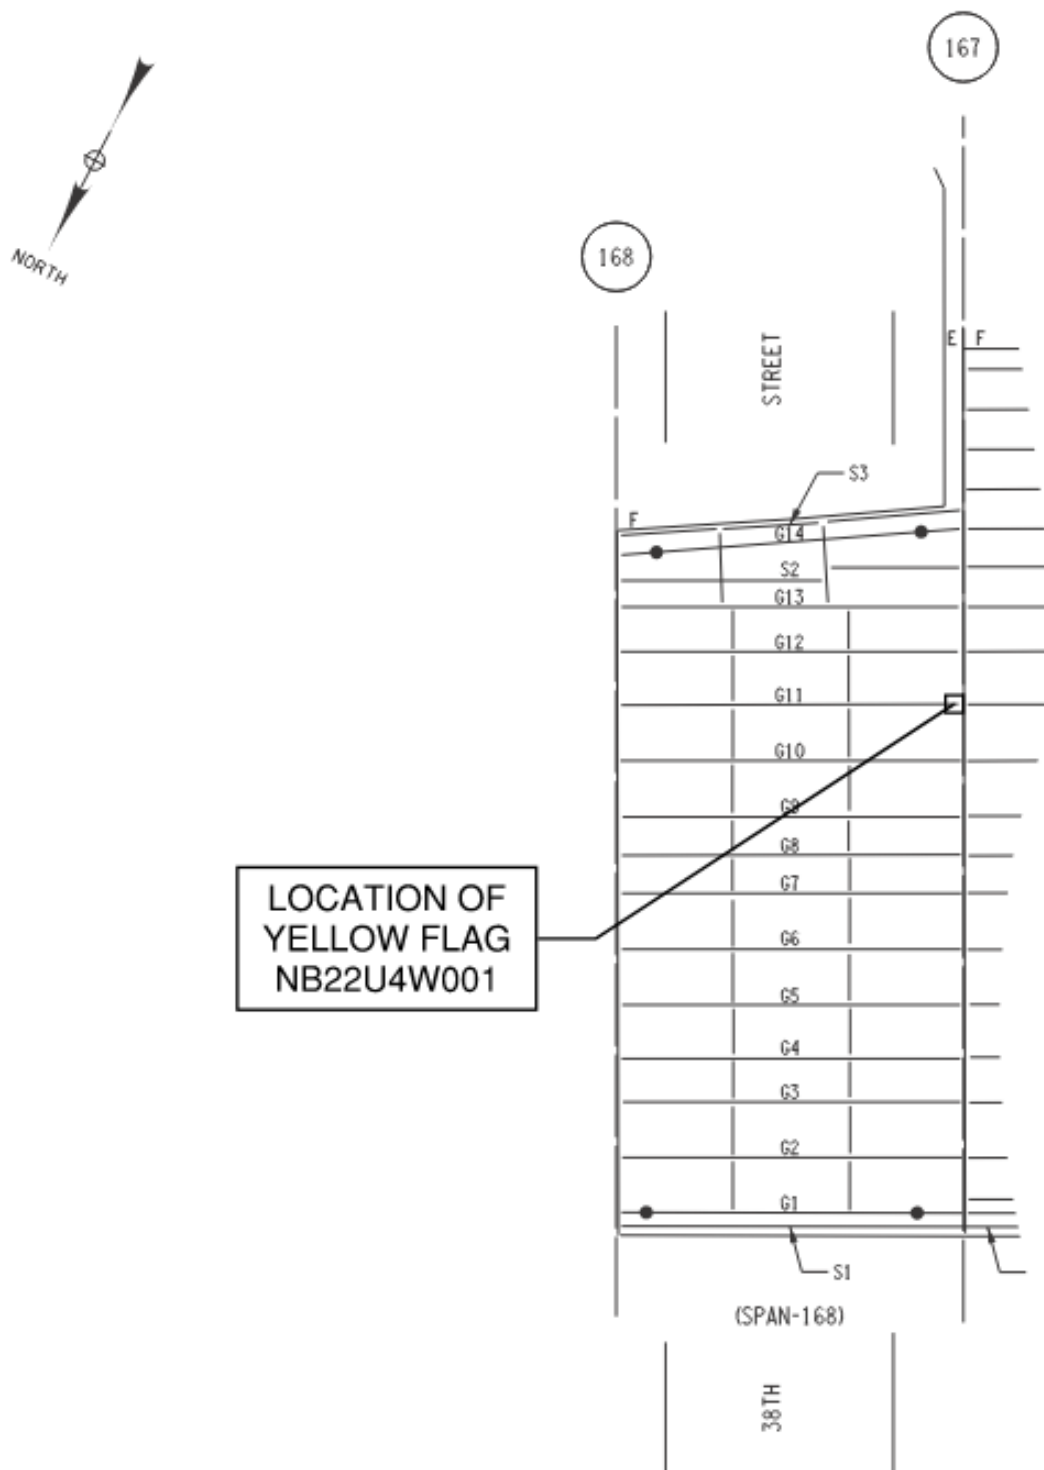
**Attachment Description: YELLOW FLAG LOCATION PLAN**

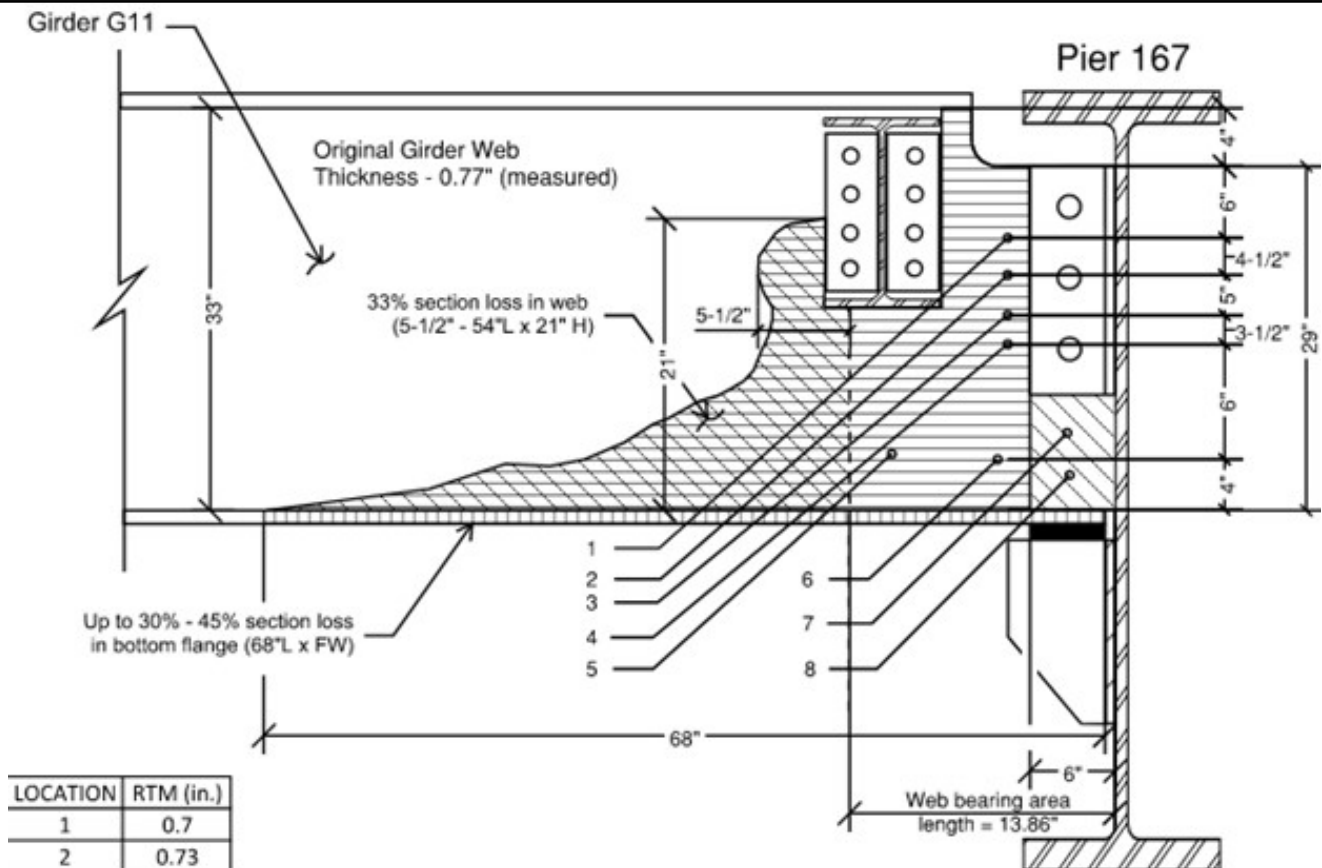
**Attachment Description: YELLOW FLAG CONDITION SKETCH 1**

Although the overall shear web area section loss is approximately only 10%, the overall bearing area web section loss is approximately 48%. (refer to Yellow Flag Condition Sketch 1, Photo #2 for more details)

LOCATION	RTM (in.)
1	0.7
2	0.73
3	0.73
4	0.68
5	0.32
6	0.63
7	0.32
8	0.28

**SPAN 168, GIRDER 11 AT PIER 167**  
**LEFT FACE (LOOKING RIGHT)**  
**N.T.S**

Original girder web thickness = 0.77" (measured)

Localized section loss in web area above bearing =  $(0.77" - 0.3") / 0.77" \times 100 = 61\%$  section loss

Web bearing area length =  $18 \times 0.77" = 13.86"$

Web bearing area =  $[ \{ ((0.32+0.28)/2) \times 6" \} + [ \{ ((0.32+0.63)/2) \} \times 7.86" ] = 5.53 \text{ in}^2$

Overall web bearing area section loss =  $[ \{ (13.86" \times 0.77") - 5.53 \text{ in}^2 \} / (13.86" \times 0.77") ] \times 100 = 48\%$  section loss

Shear web area =  $(0.7" \times 8.25") + (0.73" \times 4.75") + (0.73" \times 4.25") + (0.68" \times 4.75") + (0.63" \times 7") = 19.985 \text{ in}^2 \sim \text{Say } 20 \text{ in}^2$

Overall shear web area section =  $[ (0.77" \times 29") - 20 \text{ in}^2 ] / (0.77" \times 29") \times 100\% = 10.4\%$  section loss

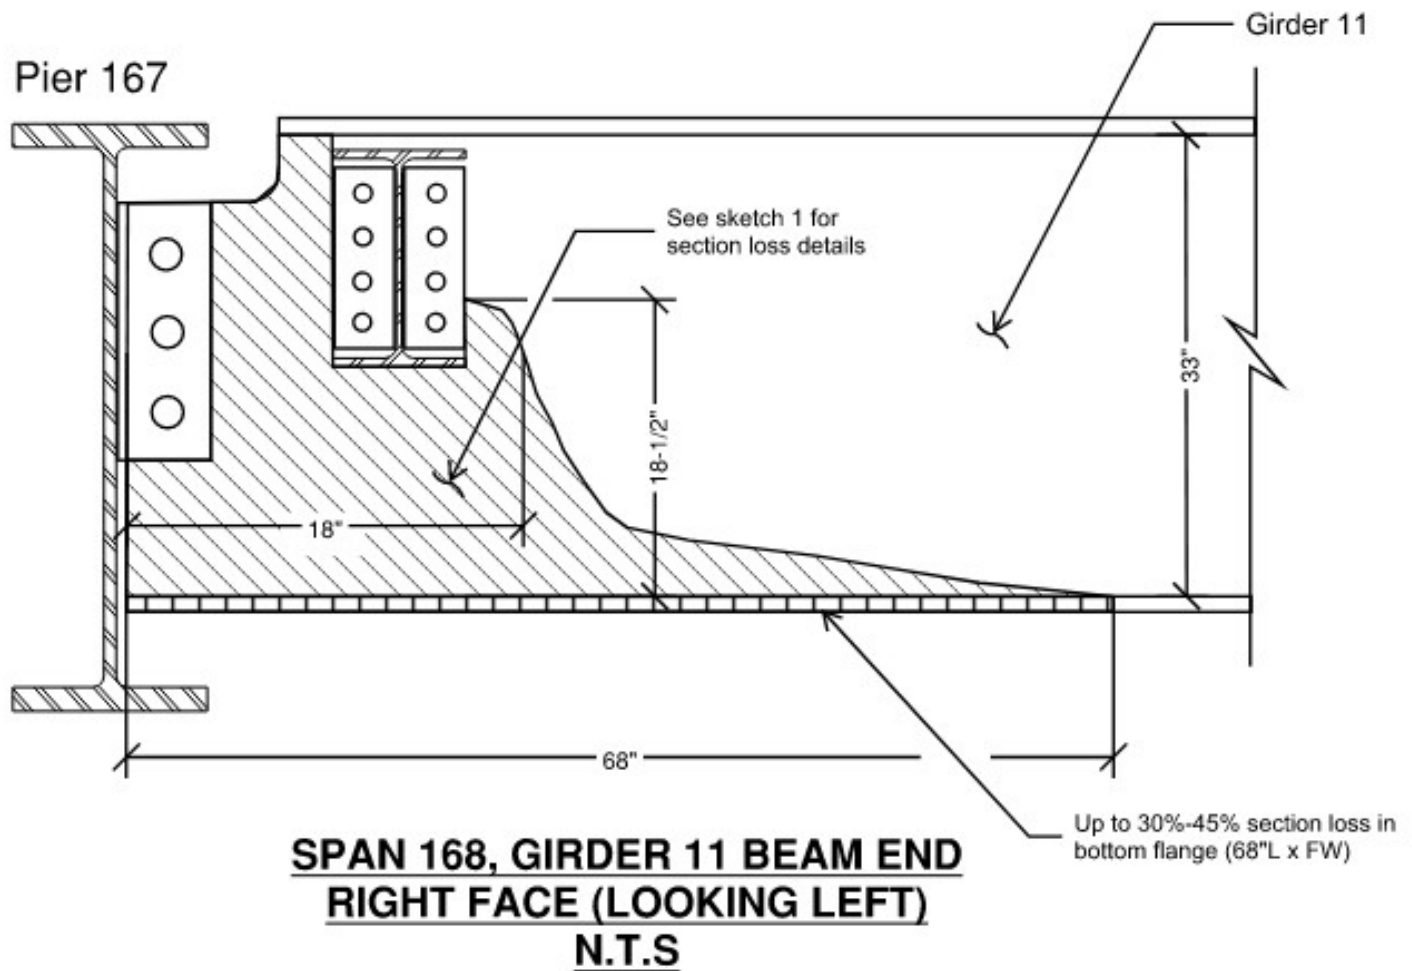
**Attachment Description: YELLOW FLAG CONDITION SKETCH 2**

The Girder G11 end at Pier 167 exhibits severe section loss with 0.3" – 0.475" remaining thickness measured (RTM) in the lower girder web in bearing area above bottom flange resulting in approximately 48% section loss. (Sketch 1, Photos 6, 8 & 9). Additionally, the bottom flange of the girder exhibits 30% to 45% section loss for 68"L for the full width of the flange (Sketch 1 & 2, Photo 8 & 9).

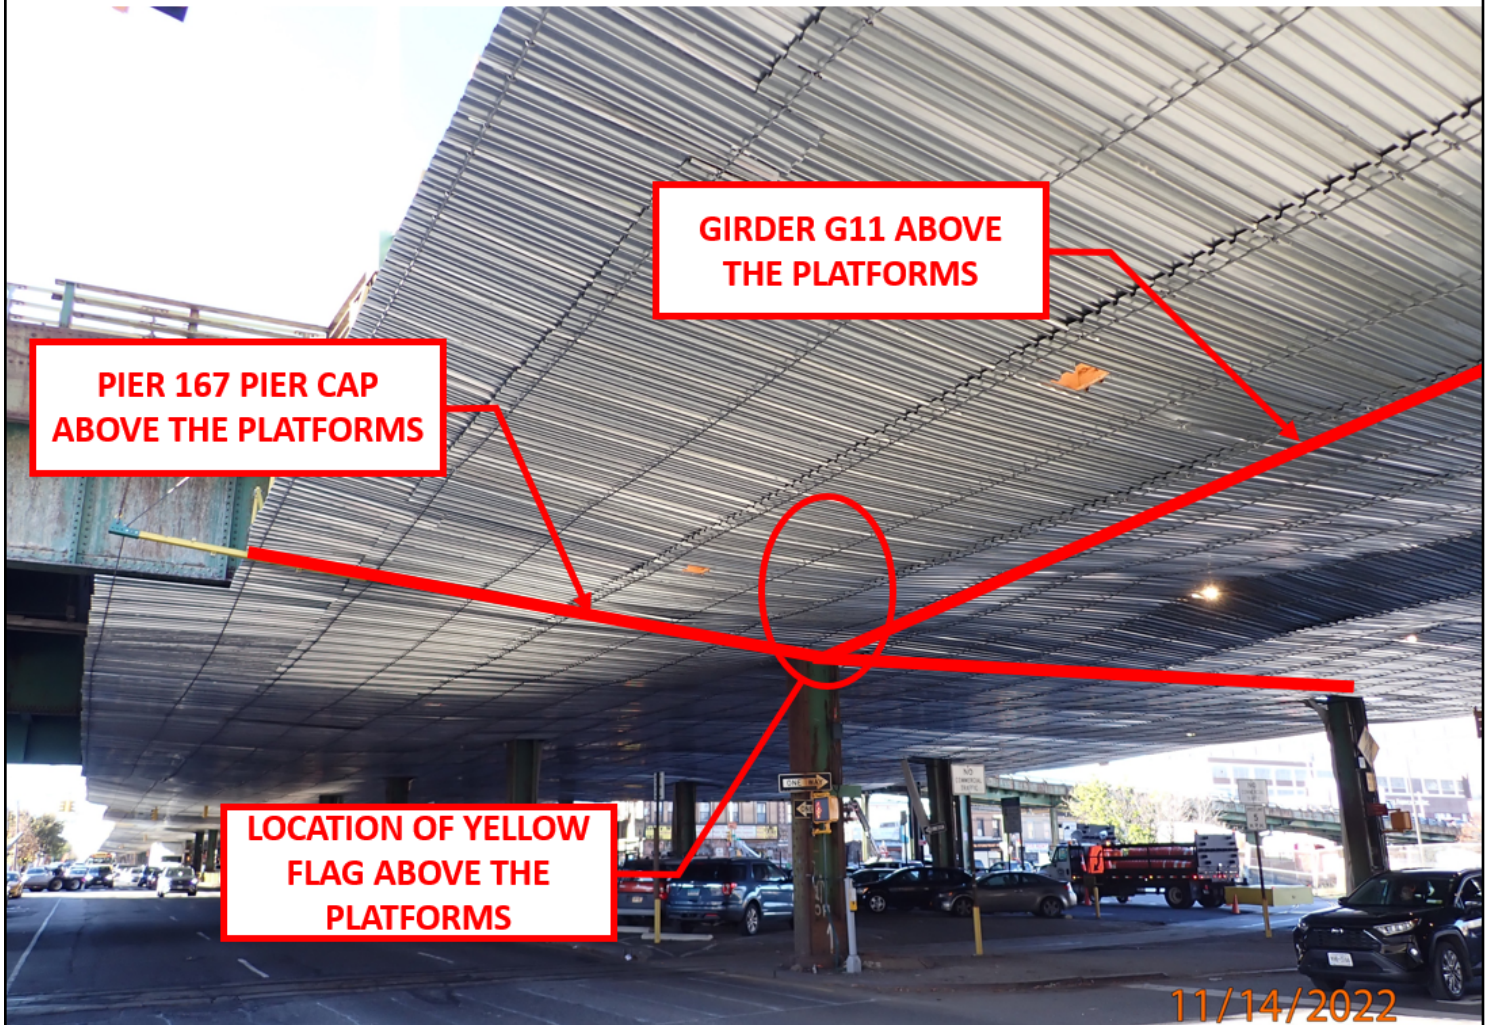
**Attachment Description:** General view of flagged condition at Girder G11 in Span 168 at Pier 167 (located above the installed shielding platform). Looking Begin - Left

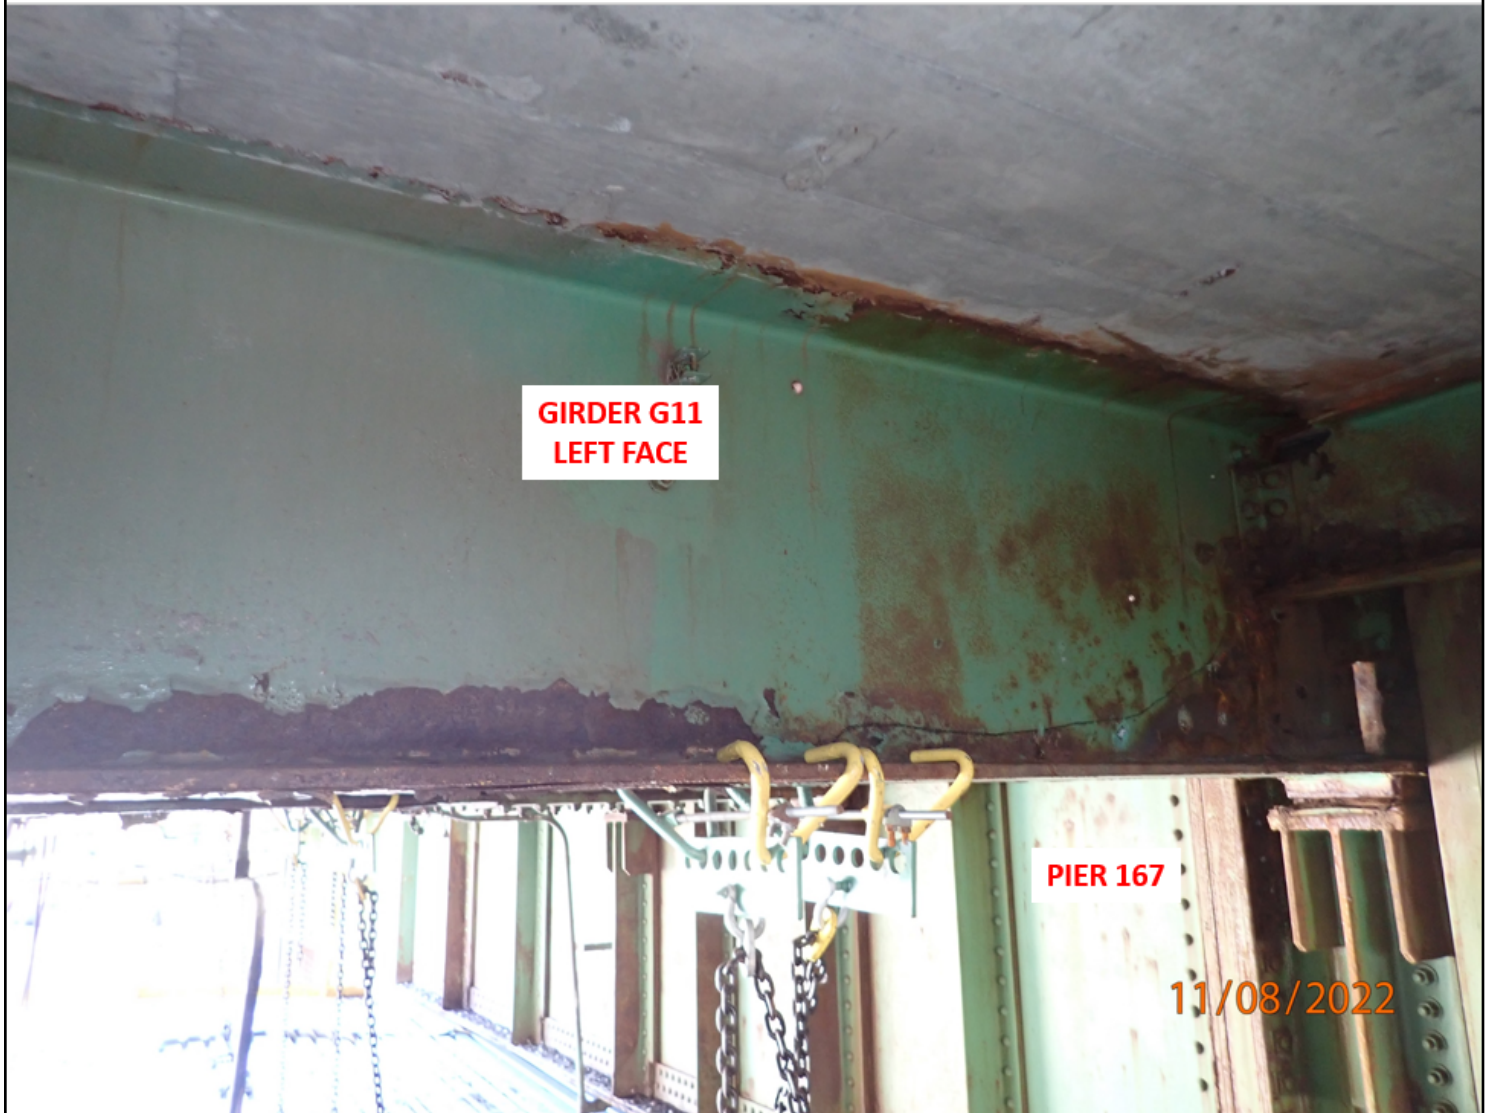
**Attachment Description:** General view of Girder G11 in Span 168 at Pier 167. Looking Begin and Right.

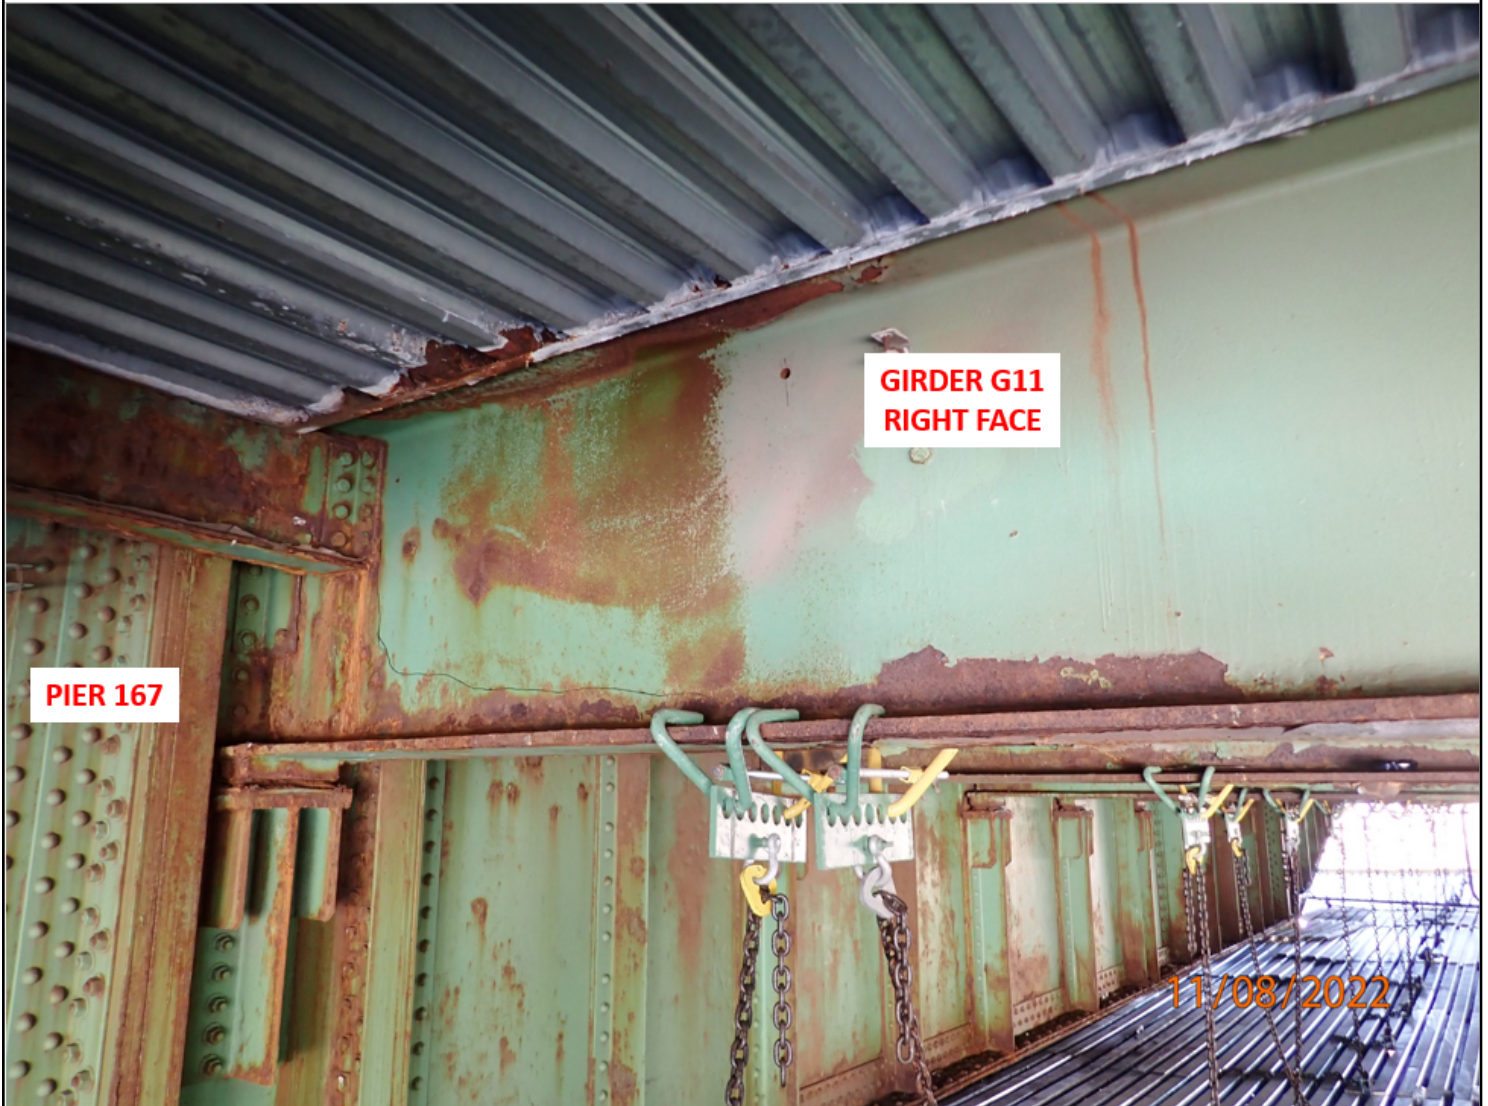
**Attachment Description:** General view of Girder G11 in Span 168 at Pier 167. Looking Begin and Left.

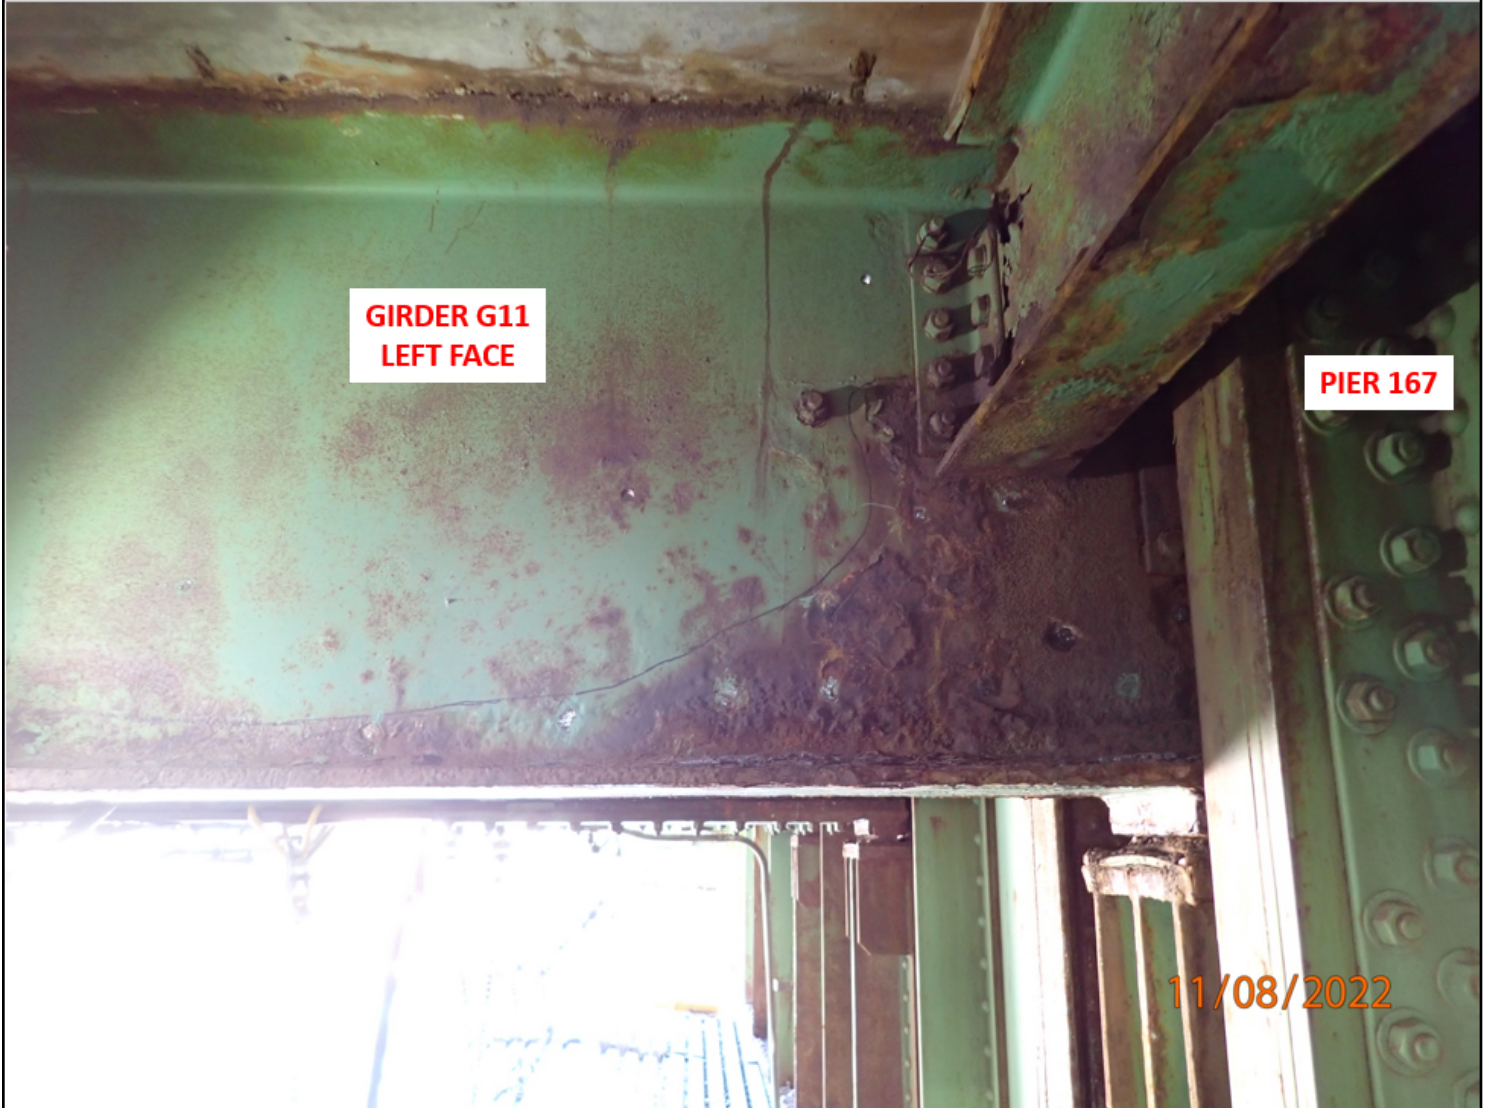
**Attachment Description:** Close-up general view of Girder G11 in Span 168 at Pier 167. The end of Girder G11 exhibits severe section loss ( approximately 48% section loss) in the lower girder web bearing area above the bottom flange. Additionally, the bottom flange of the girder exhibits 30% to 45% section loss for 68"L for the full width of the flange. Looking Right.

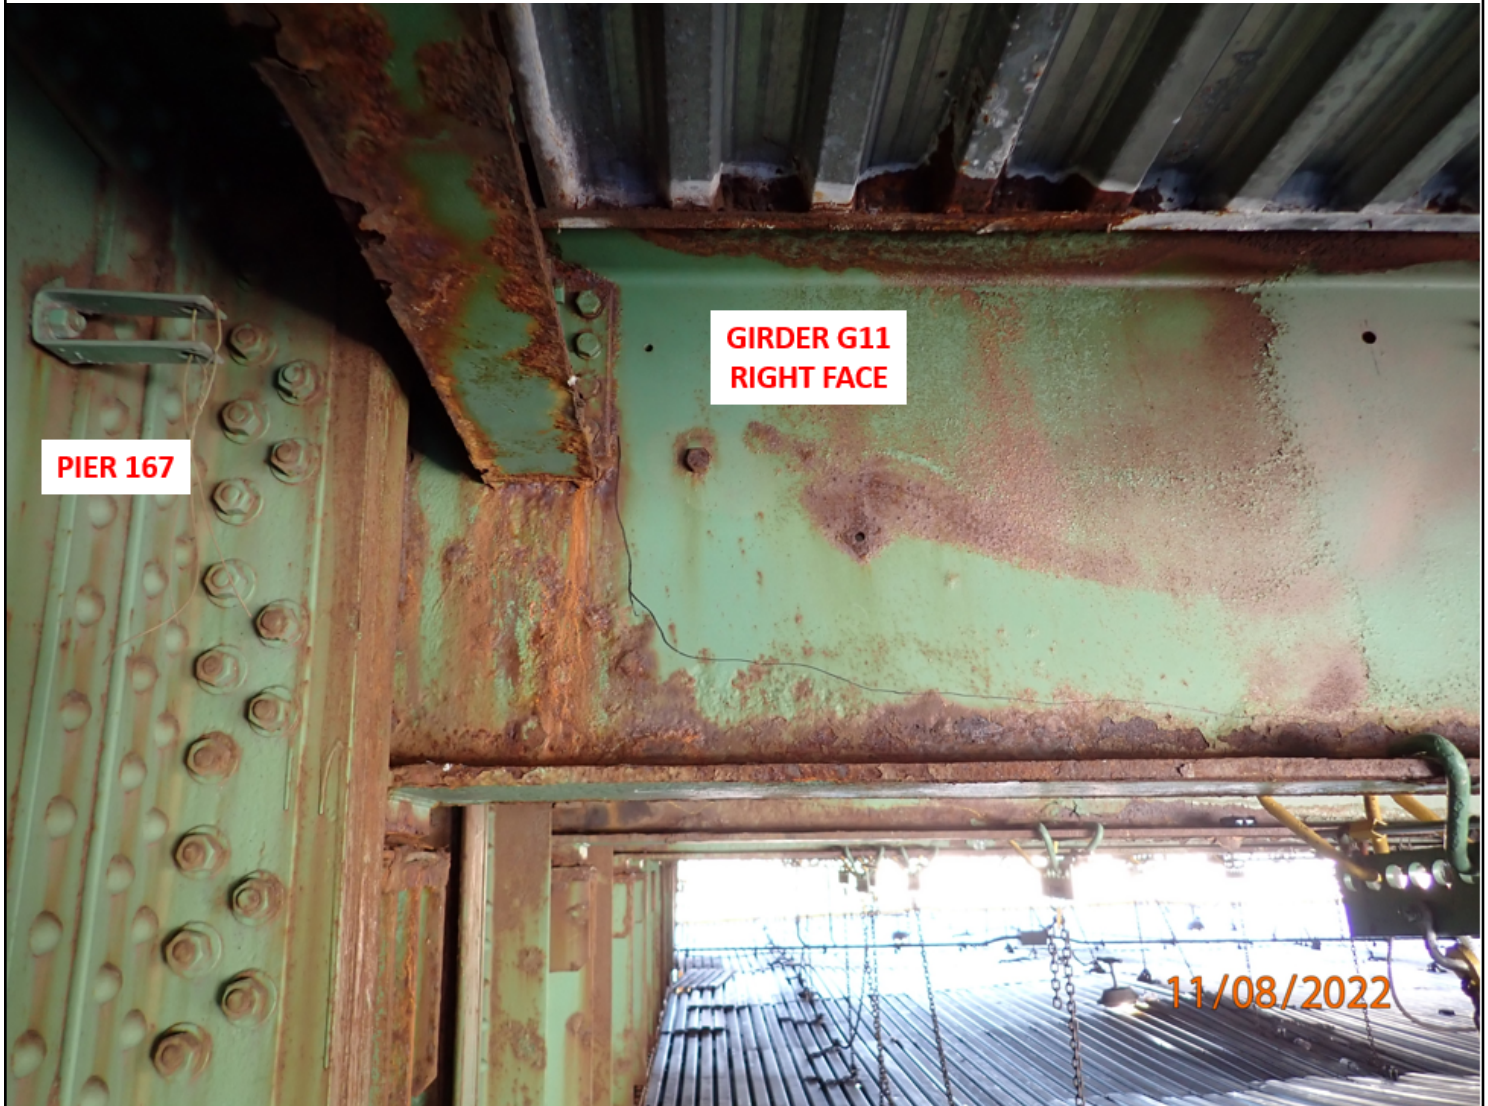
**Attachment Description:** Close-up general view of Girder G11 in Span 168 at Pier 167. The end of Girder G11 exhibits severe section loss ( approximately 48% section loss) in the lower girder web bearing area above the bottom flange. Additionally, the bottom flange of the girder exhibits 30% to 45% section loss for 68"L for the full width of the flange. Looking Left.

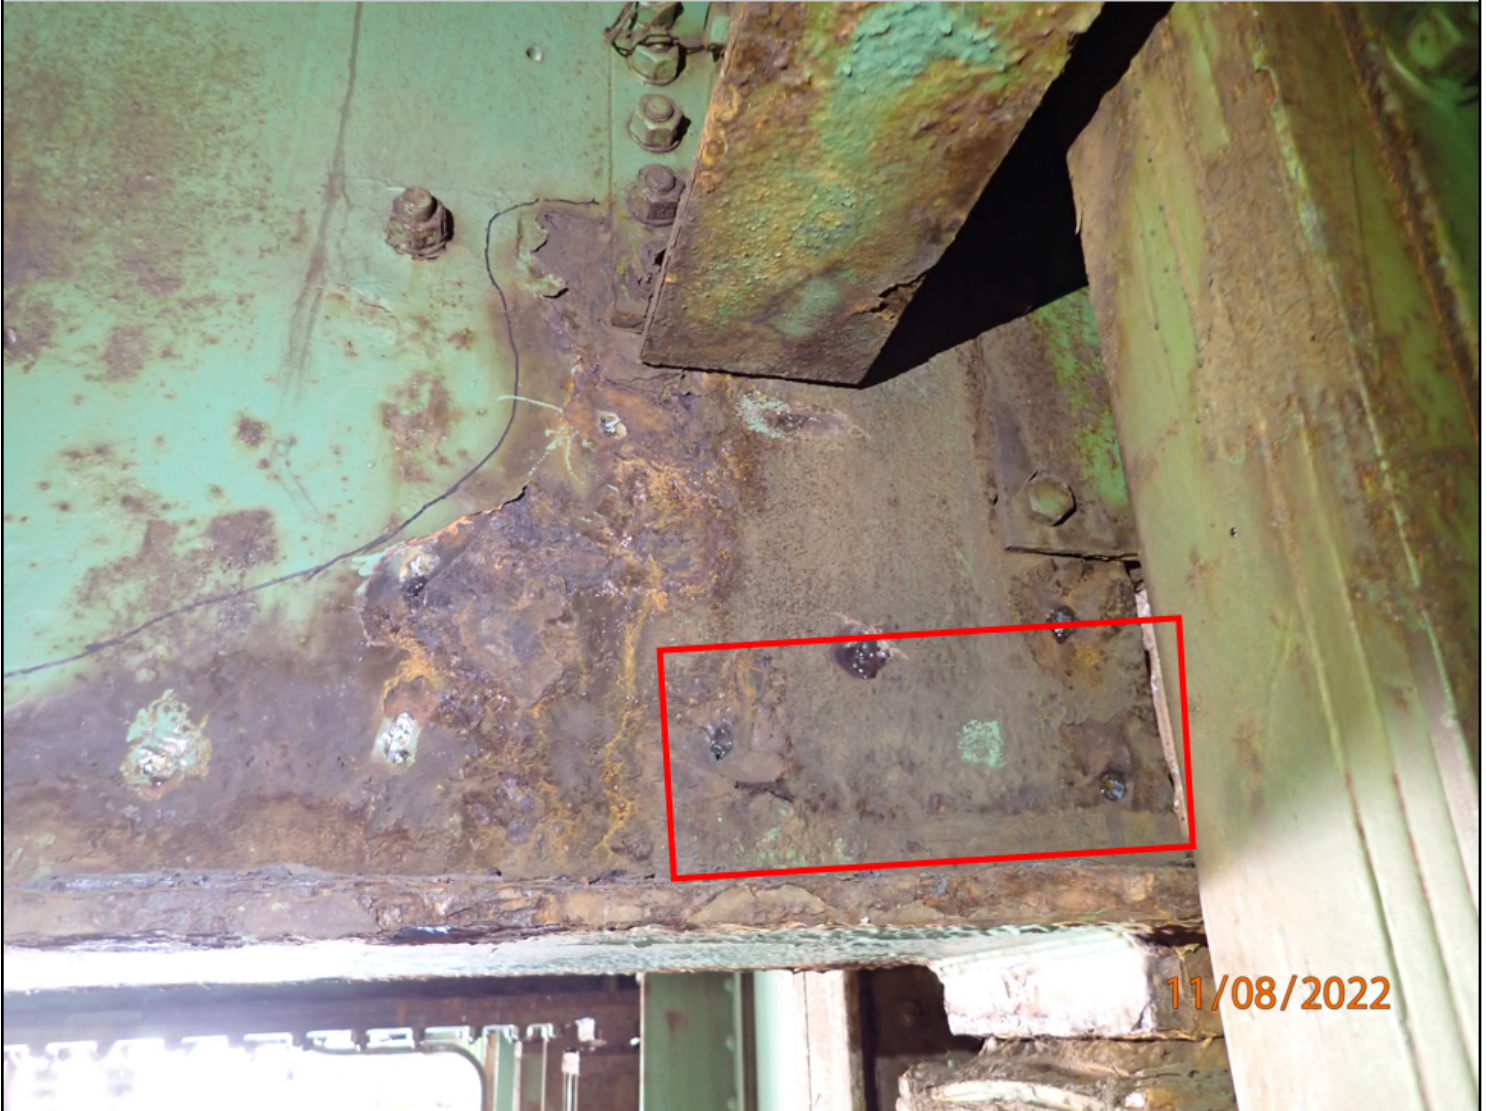
**Attachment Description:** The Girder G11 End exhibits severe section loss ( approximately 48% section loss) in the lower girder web in bearing area above bottom flange. The bottom flange of the girder on left face exhibits 30% to 45% section loss for 68"L for the full width of the flange. Looking Right.

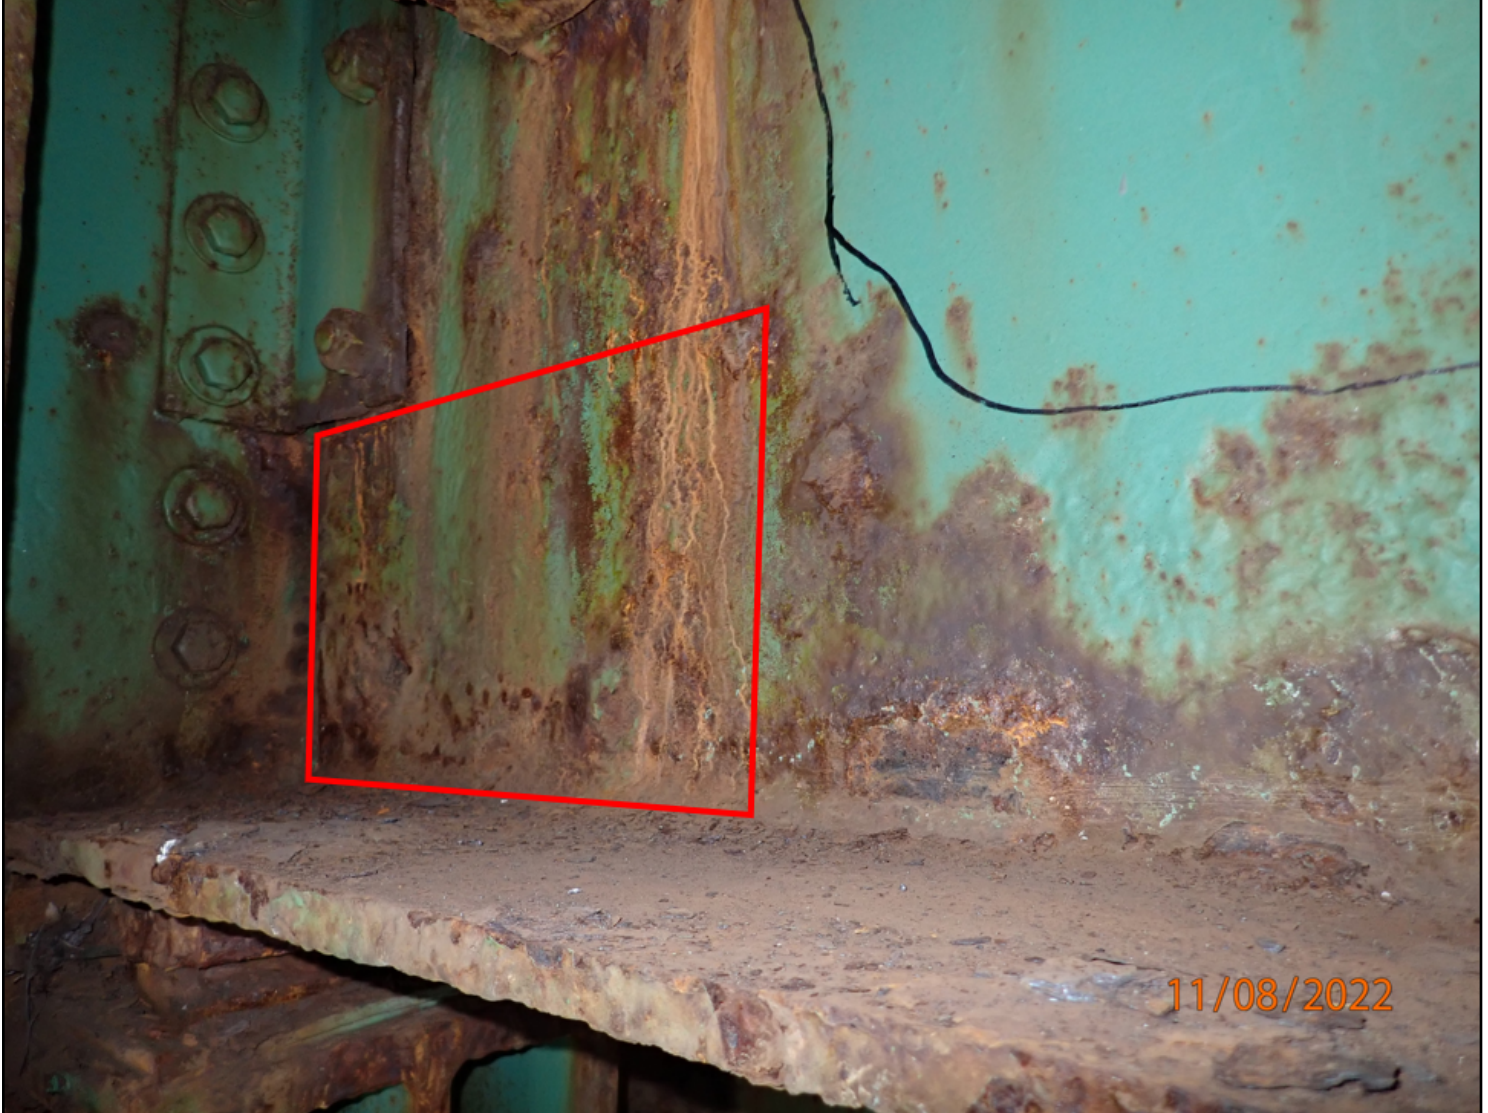
**Attachment Description:** The end of Girder G11 exhibits severe section loss ( approximately 48% section loss) in the lower girder web in bearing area above bottom flange. The bottom flange of the girder on left face exhibits 30% to 45% section loss for 68"L for the full width of the flange. Looking Left.
